FLOOD PLAIN INFORMATION REPORT

BLACK RIVER
NEW YORK, LEVEL #

DEFERIET DAM TO CONFLUENCE
DEER RIVER.

NOVEMBER 1977

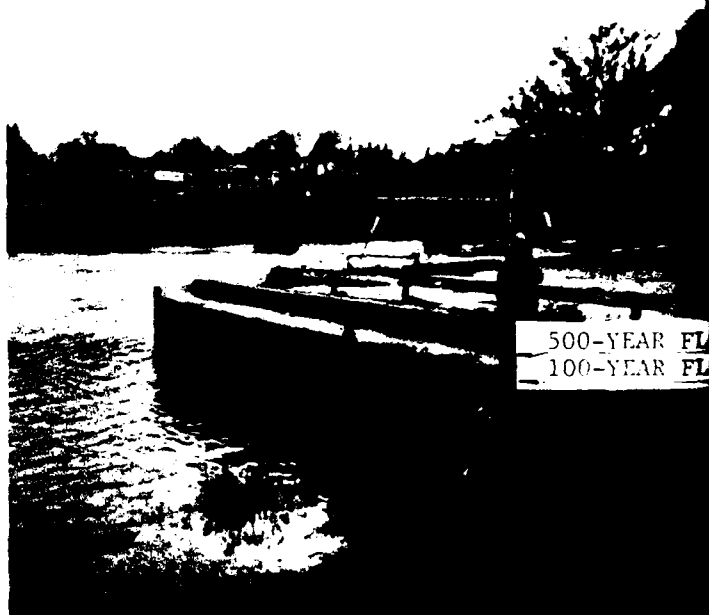
Possible future flood heights at
a parking lot in Carthage at stream mile 32.2.

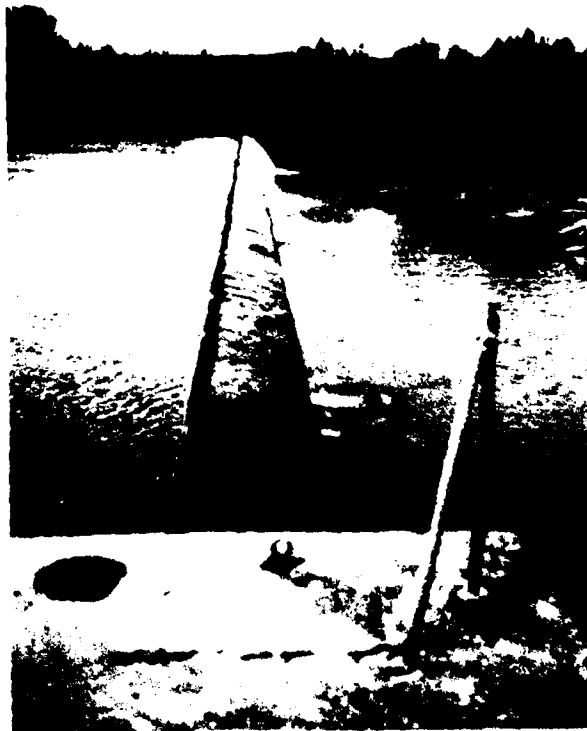
Figure 1 - Crest of Deferiet Dam,
stream mile 26.53.

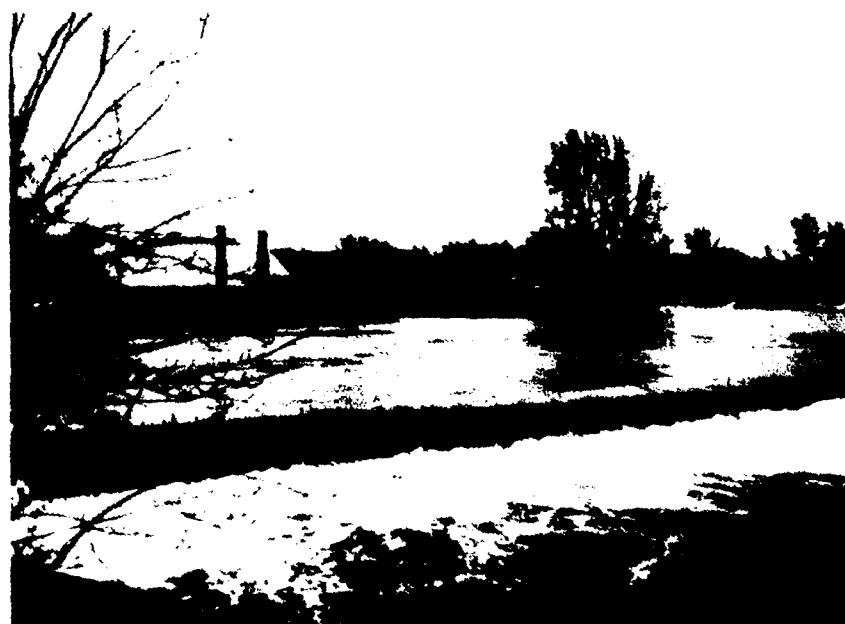
Figure 4 - Low dam along right bank at stream mile 31.82.

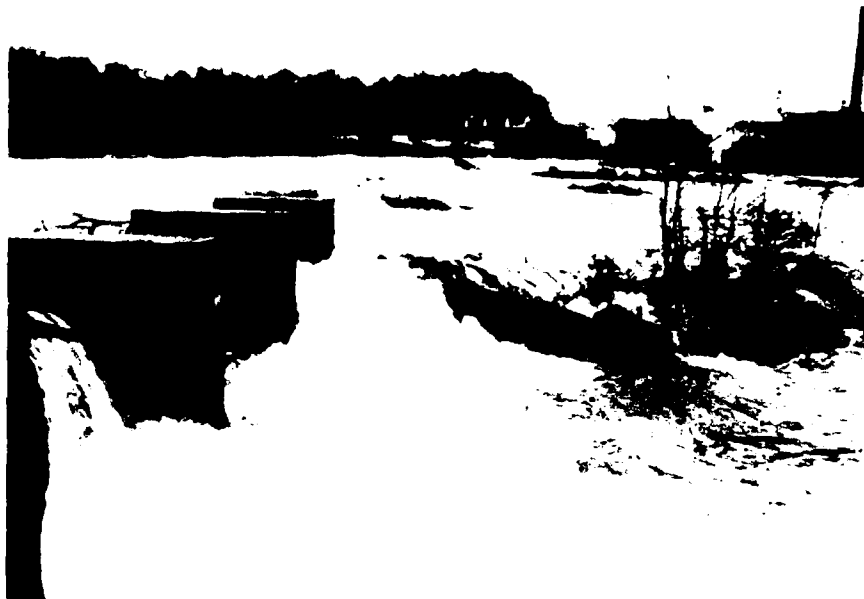
Figure 5 - Crest of Carthage State Dam at stream mile 31.92.

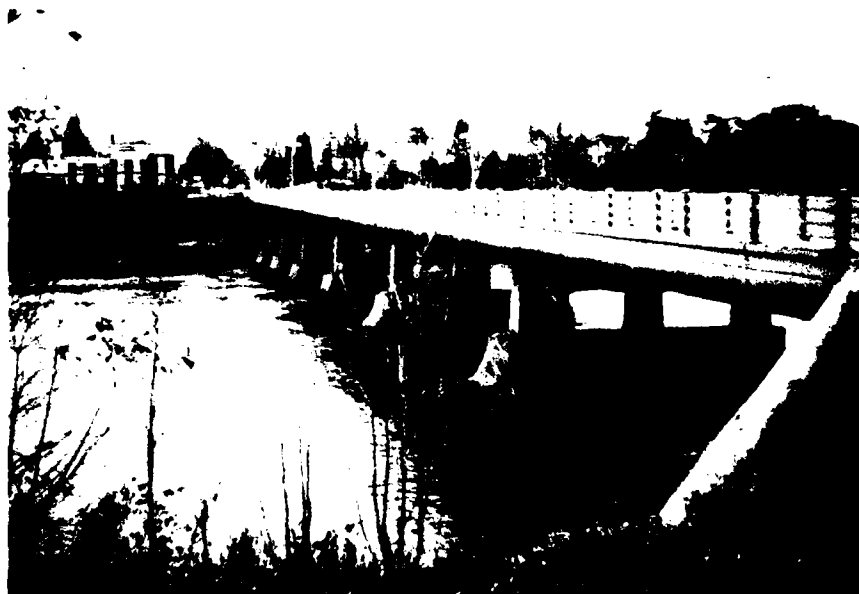
Figure 6 - Upstream face of State Route 26 bridge at stream mile 32.14.

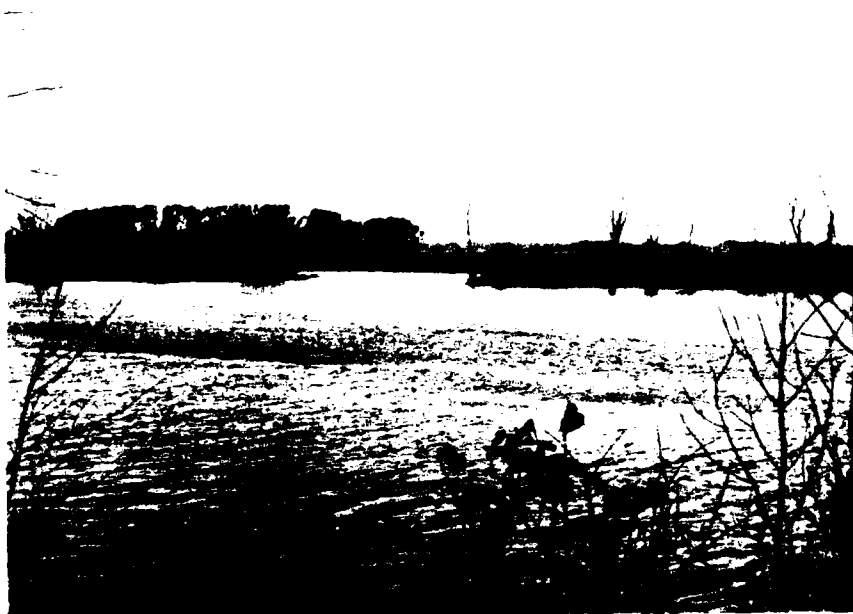
Figure 8 - Mouth of Deer River at Black River at stream
mile 37.22.

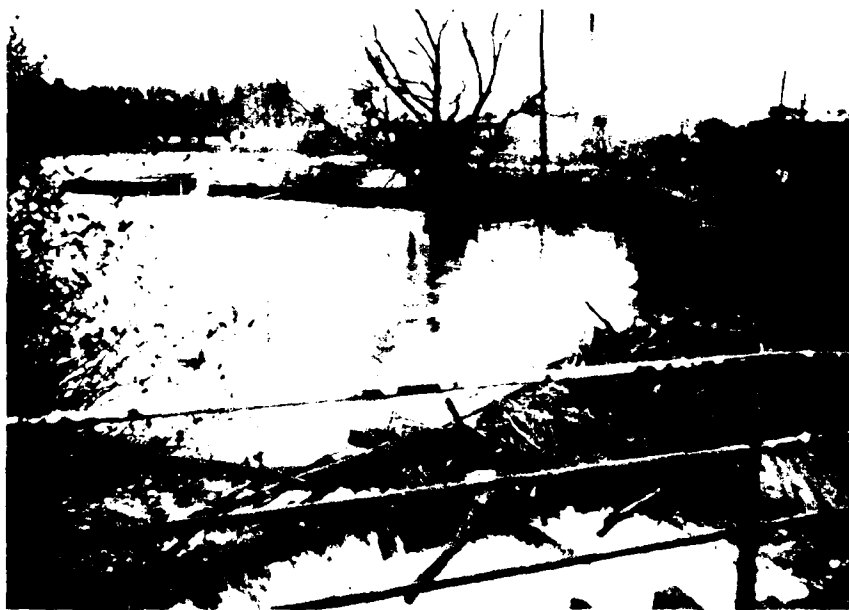
Figure 10 - Debris near bridge at mill race, stream mile 31.82.

Generally, obstructions at bridges and culverts restrict flows, raise water surface elevations in overbank areas and result in unpredictable areas of flooding, destruction, and damage. Since it is impossible to predict the degree or location of the accumulation of debris, therefore, for the purposes of this report, it was assumed that there would be no accumulation of debris at any of the bridges or culverts. Photographs of typical bridges, dams and other stream characteristics are shown on Figures 1 through 8. Examples of obstructions to flow are shown on Figures 9 and 10.

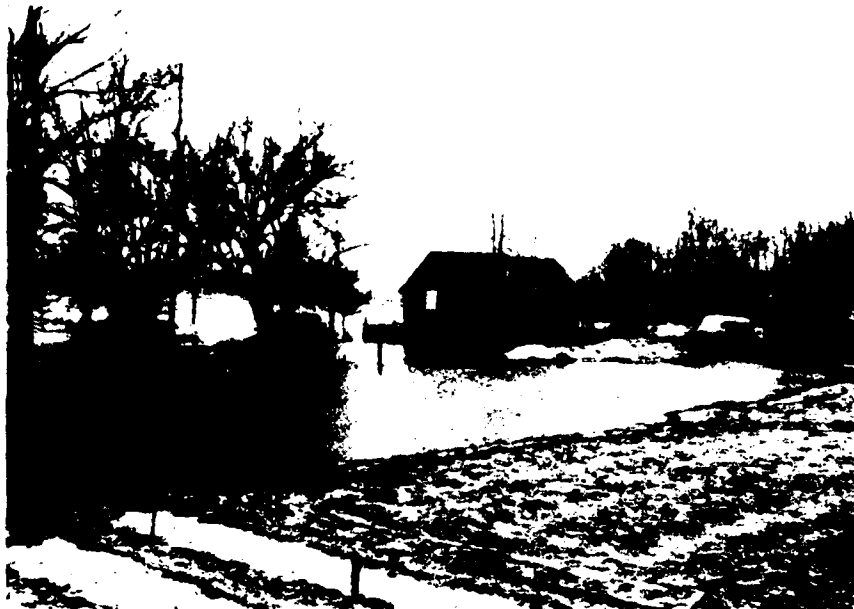
Figure 11 - Flooding conditions in March 1977 at barn on west side of State Route 3 in town of Wilna at stream mile 28.26.

Agricultural damage consisted of: losses to farm lands, farm equipment and buildings and loss of milk production and shipment. In the fields there were widespread standing flood waters that were from 1/2 to two miles wide and six feet deep. Flooding conditions in March 1977 are shown on Figures 11 through 14.

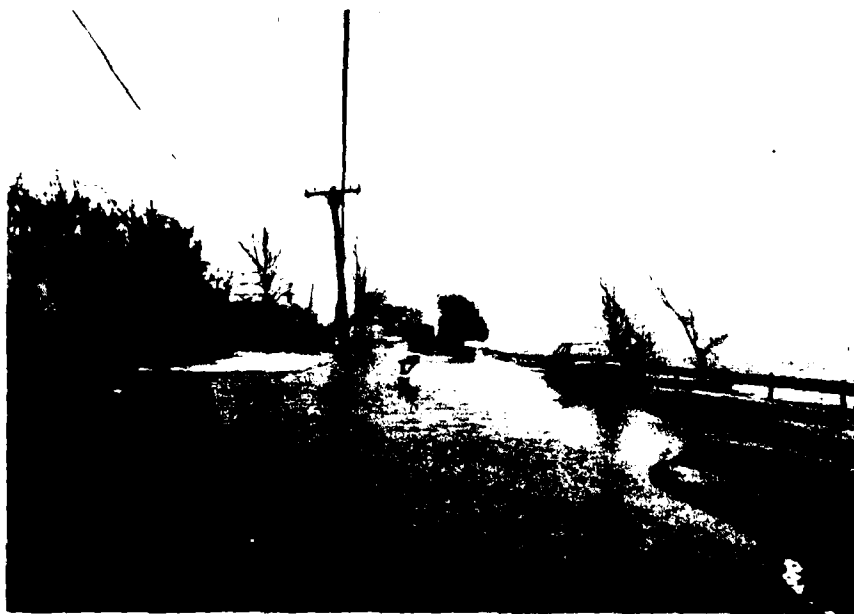
Figure 12 - Flooding conditions in March 1977 along State Route 3 in town of Wilna at stream mile 28.66.

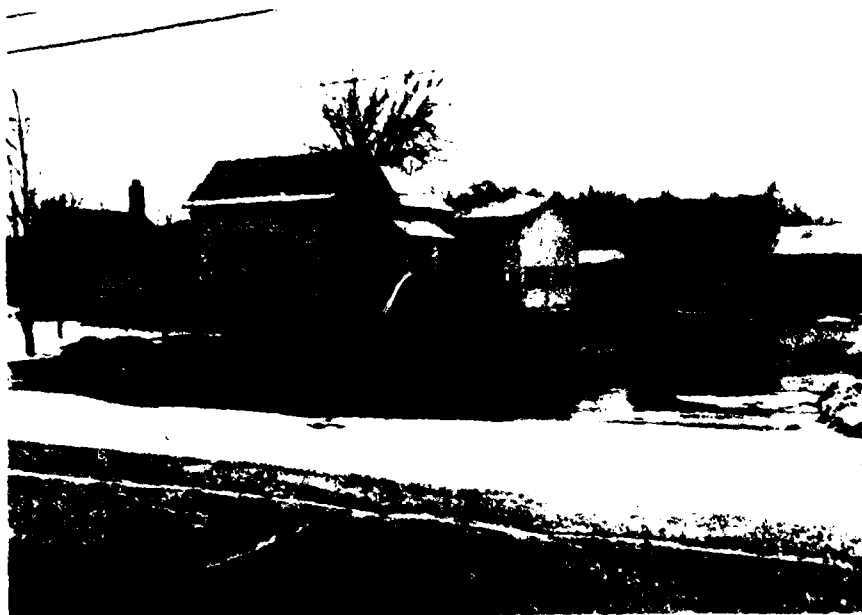
Figure 13 - Flooding conditions in March 1977 at east side of State Route 3 in town of Wilna at stream mile 30.84.

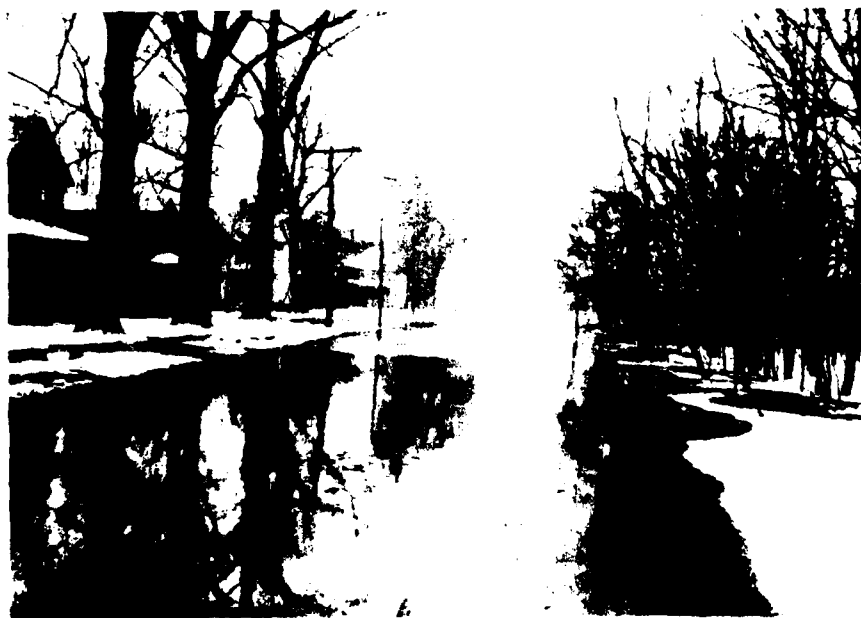
Figure 14 - Flooding conditions in March 1977 along South Mechanic Street in village of Carthage at stream mile 32.35.

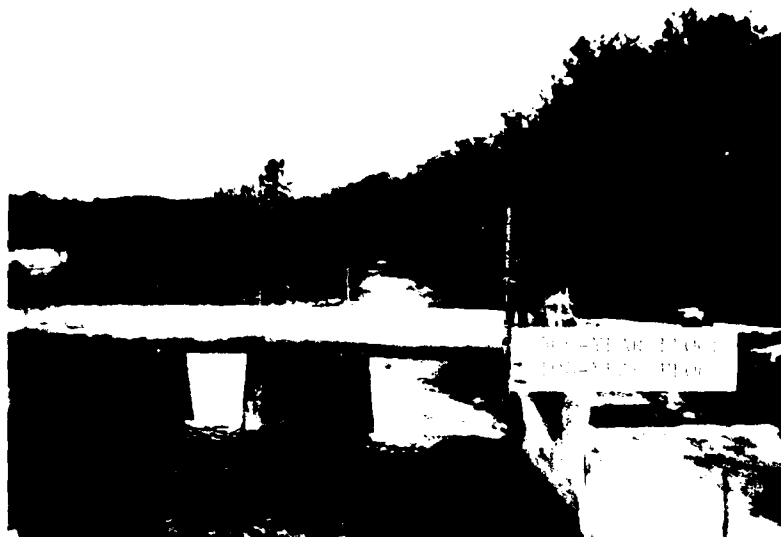
Figure 15 - The 100- and 500-year flood heights at the Deferiet Dam at stream mile 26.53 are shown.

The expected levels of the 100-year and 500-year floods at various locations in the study area are indicated on Figures 15 through 20.

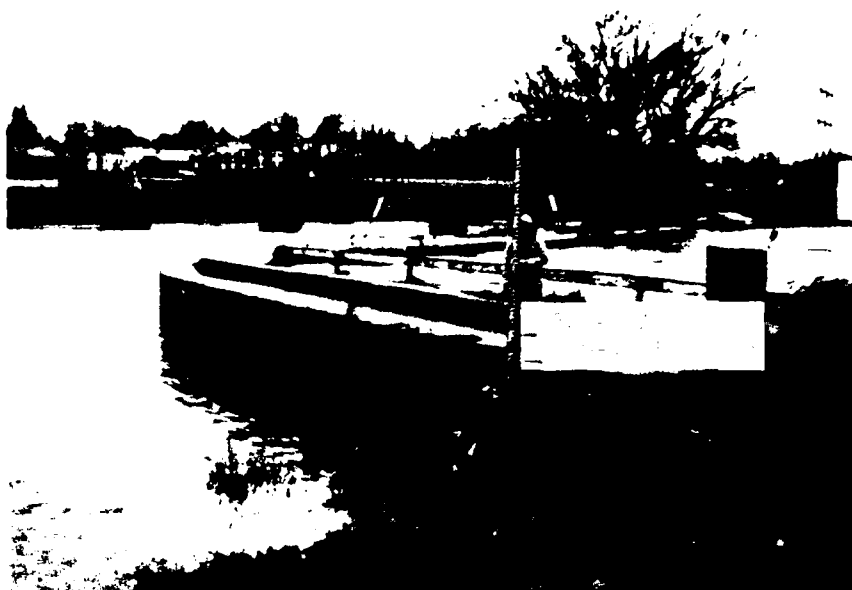
Figure 19 - The 100- and 500-year flood heights at parking lot in Carthage at stream mile 32.2 are shown.
